TECHNICAL REPORT NR. 52 711

Nature of Work: Technological Testing on artificially colored stone

Client: Royal Marble & Granite Ltd.

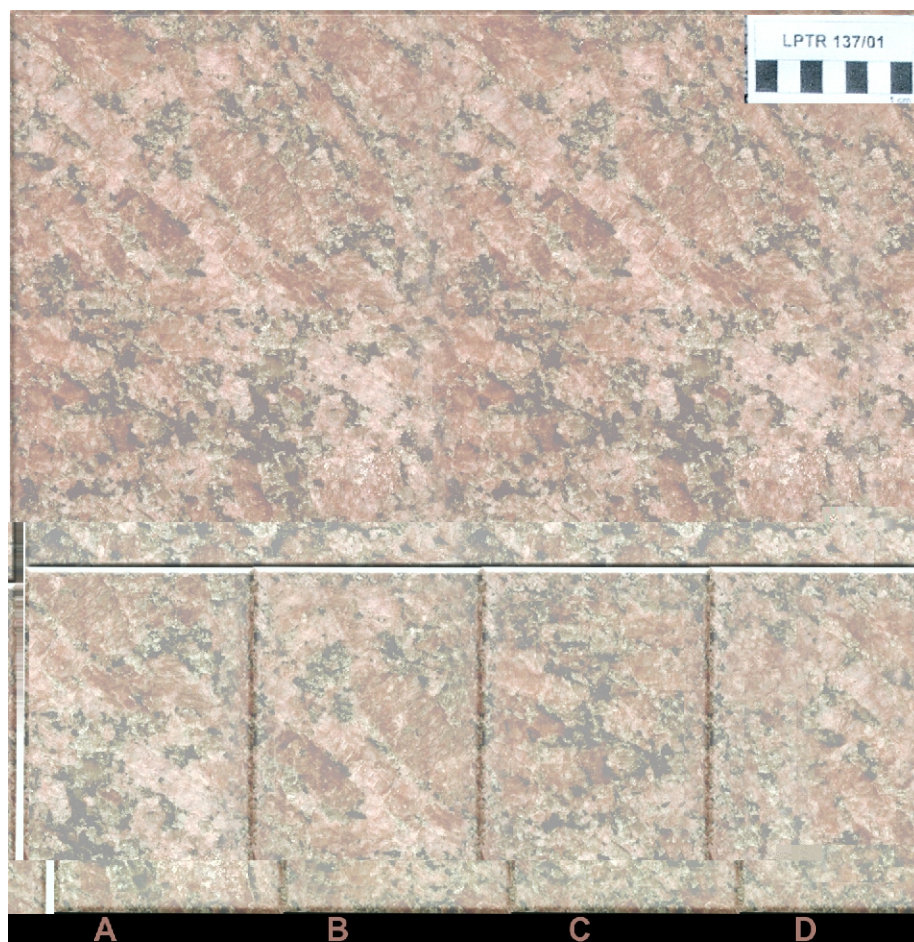
Four 15x10cm tiles were sawed from a 40x20x2cm tile. Three of them (A, B and C) underwent the test and the fourth (D) was used as reference. (PICTURE 1)

PICTURE 1 - Samples used in the artificial light and water exposure test.

The testing for accelerated ageing consisted of 4-hour cycles of ultraviolet radiation (UV) at 60 degrees Celsius and of four hours of condensation at 50 degrees Celsius. The evaluation of the effects was carried out at intervals of 100 hours and after the exposure. The test samples were photographed before and after the final exposure.

The C-UV chamber “Accelerated Ageing System for Non-Metallic Materials”, of the COMEXIM (pictures 1 and 2) and ultraviolet-B fluorescent lamp bulbs, type TL 40W/12RS, manufactured by PHILIPS. The mains peaks are 313nm and 370nm (UVB), with radiance of 0,850-90 and 0,30 Wm²/nm, respectively.

After 400 hours, the face exposed to ultraviolet light had its color slightly altered to a lighter tone. After 600 hours, which are equivalent to approximately 2 years of exposure, the effect was still slightly altered.
